Sony Vaio PCG-4G1L Plastic Casing Replacement

A demonstration on how to remove and replace the plastic casing for the Sony Vaio PCG-4G1L device.

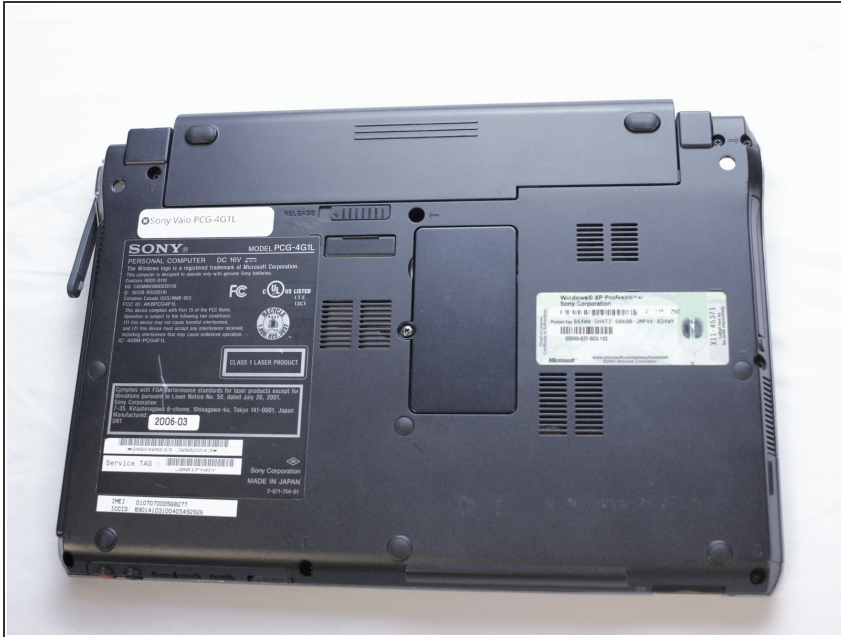
Step 1 — Battery

- Turn off the computer and disconnect the charging cable.

⚠ Failing to unplug the cable can result in electric shock.

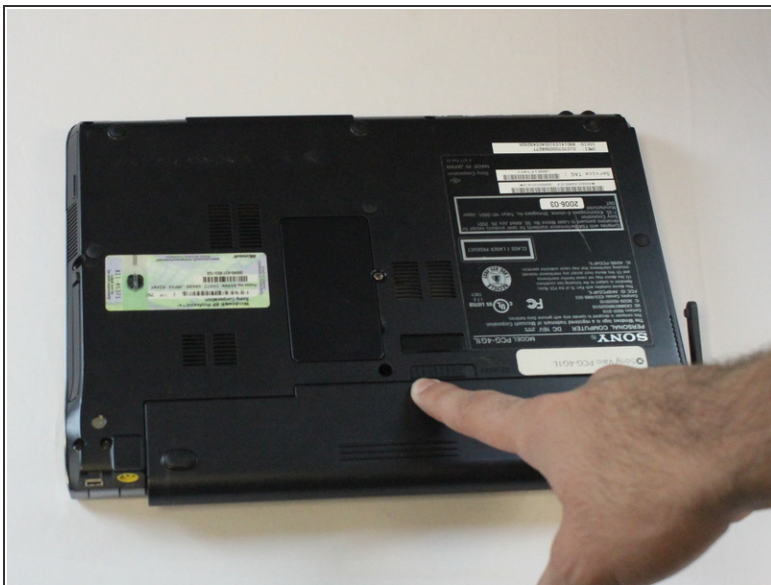
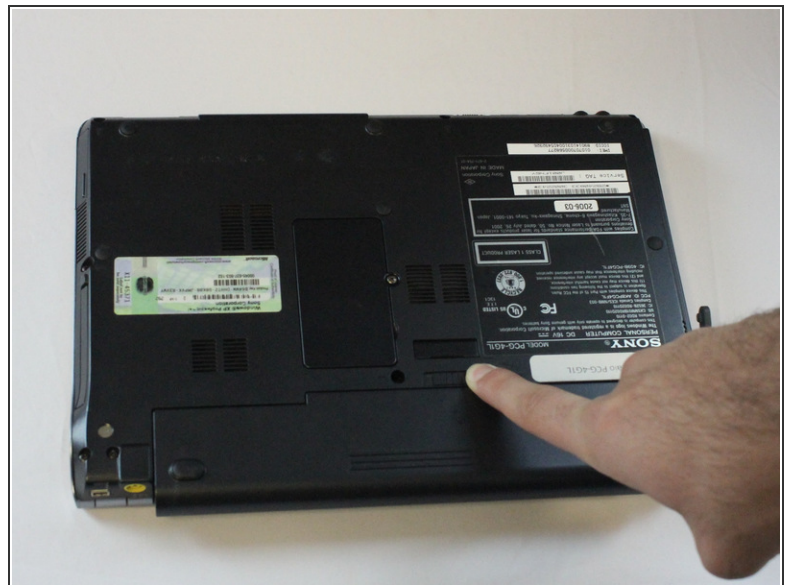
Step 2

- Slide battery release toggle switch towards the "RELEASE" print.

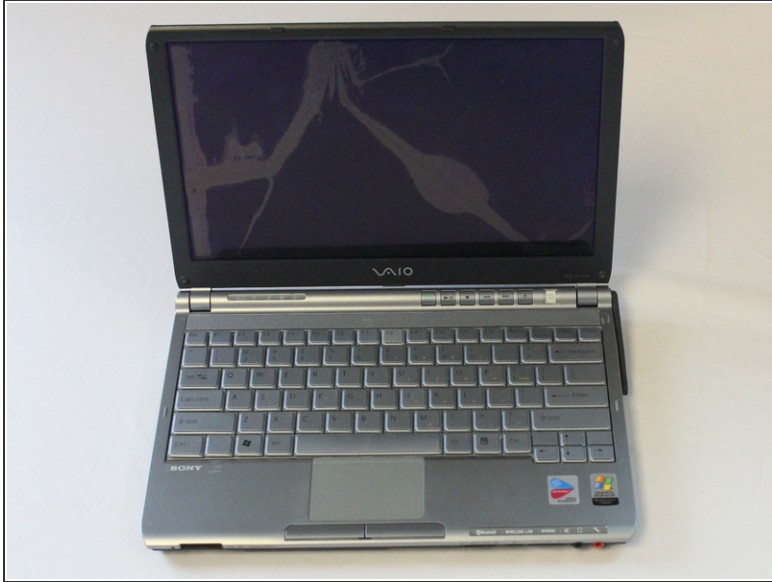
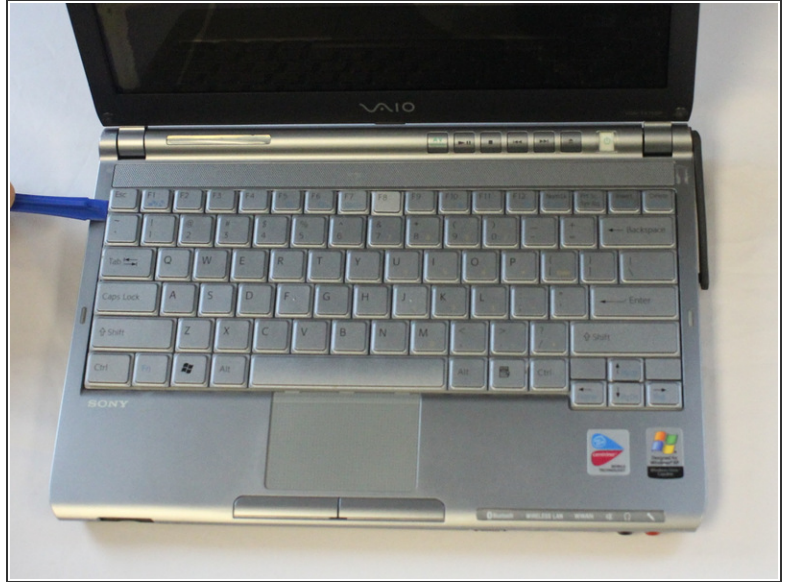
Step 5

Be sure to pry the plastic opening tool under the keyboard, rather than under the keys. Otherwise, some keys could get harmed.

- While using a plastic opening tool, carefully lift the keyboard by inserting the tool under the edge.

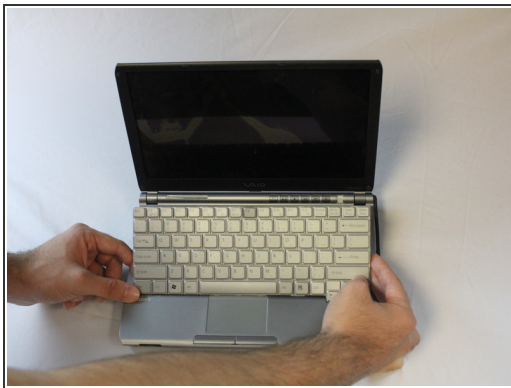
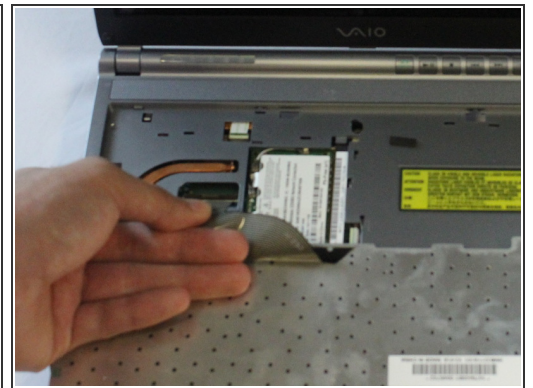
Step 6

Do not pull the keyboard too far away, as a ribbon cable is still attached. Failing to do so can cause damage to the ribbon cable or the connector.

- Use the plastic opening tool to release the clamp.
- Using slight pressure, remove the ribbon cable with your fingers.

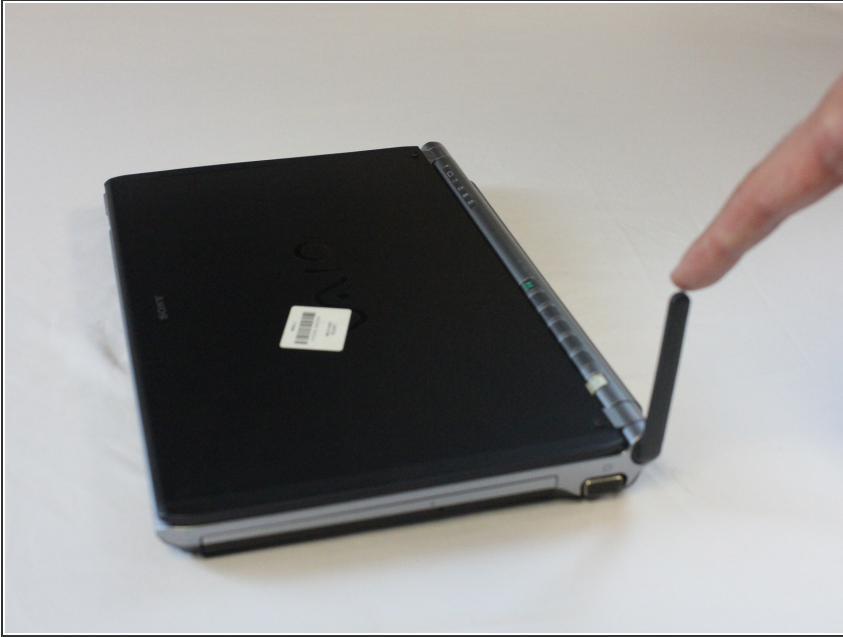
Step 7 — Network Antenna

- Swivel the Network Antenna up so that it points upward.

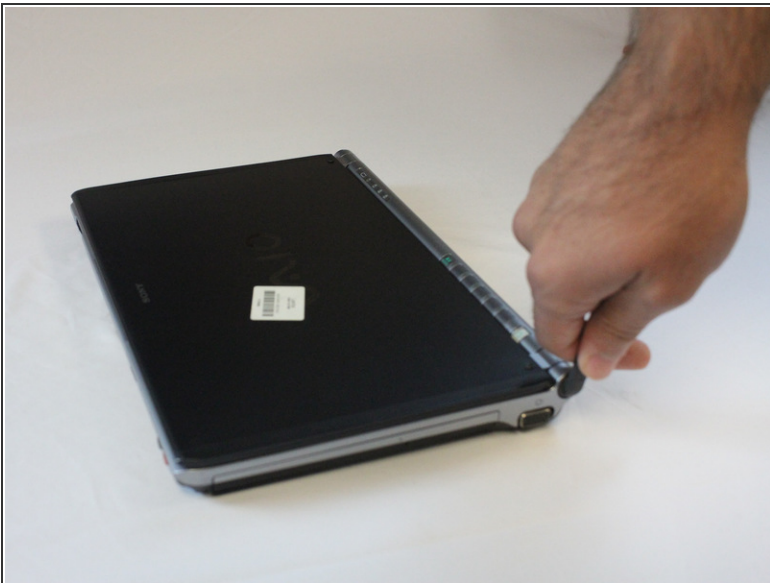
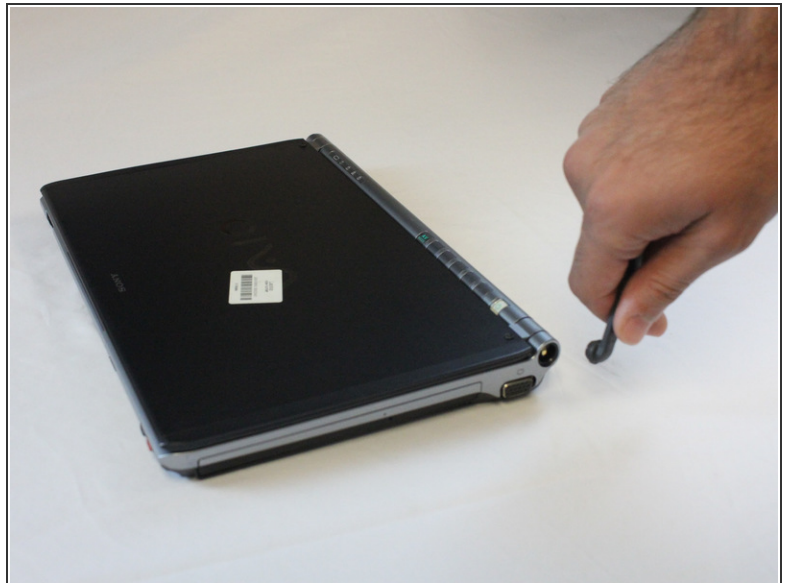
Step 8

- Pinch thumb and index finger at the Network Antenna's base.
- ⚠ Make sure not to bend the Network Antenna. Failing to do so can cause damage to the antenna.
- Pull the Network Antenna off.

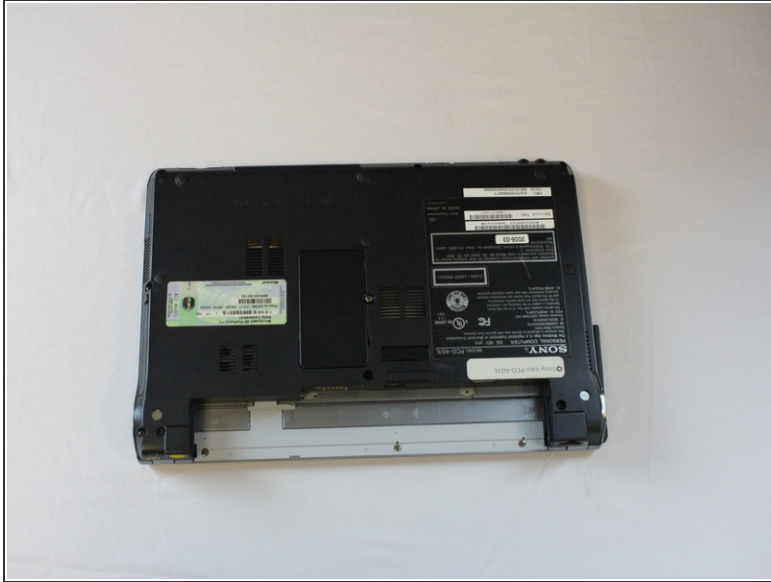
Step 9 — Plastic Casing

- Remove seven 5 mm Phillips #1 pan head screws with a Bit Driver, using a Phillips PH1 bit.

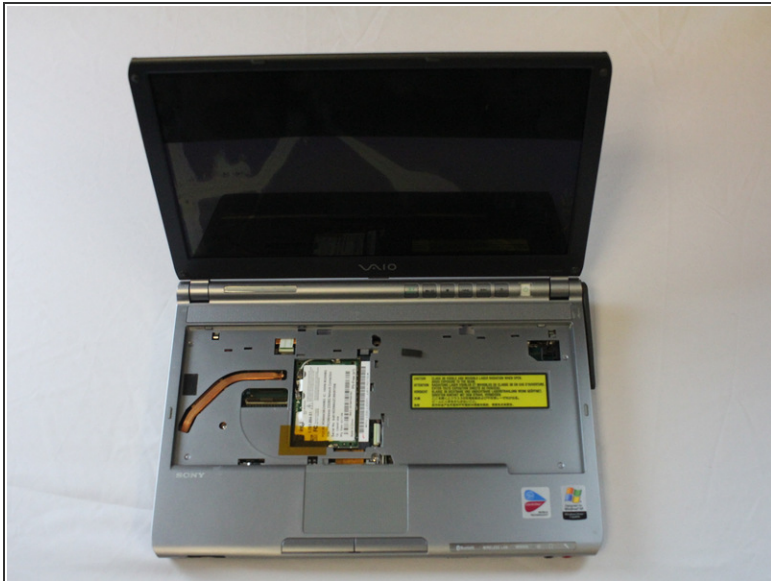
Step 10

- Remove one 7 mm Phillips #1 Pan Head Screw by using a Bit Driver with Phillips PH1 bit.

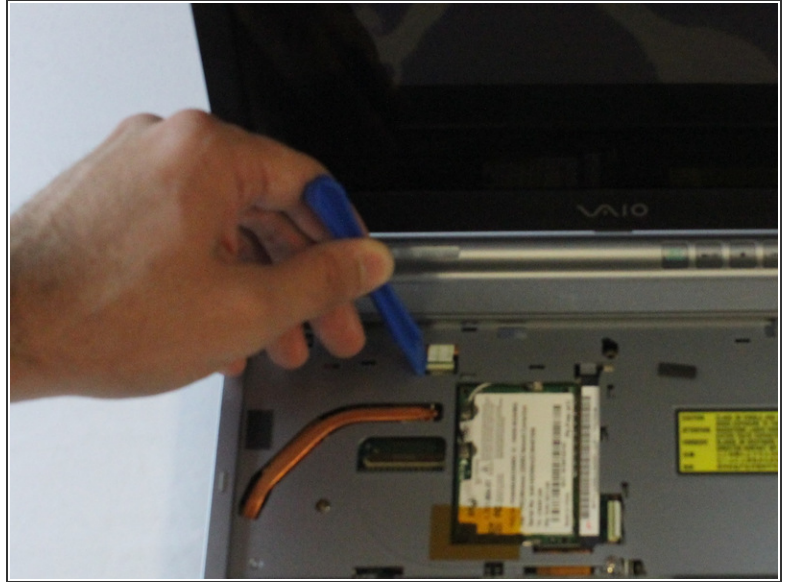
Step 11

- Disconnect the cable by using the precision tweezers.
- Slowly pry out the ribbon cable by using the plastic opening tool.
